# Milton Keynes Waste Recovery Park

## Annual Performance Report Jan 2019

**Milton Keynes Waste Recovery Park  
2018 Annual Performance Report**

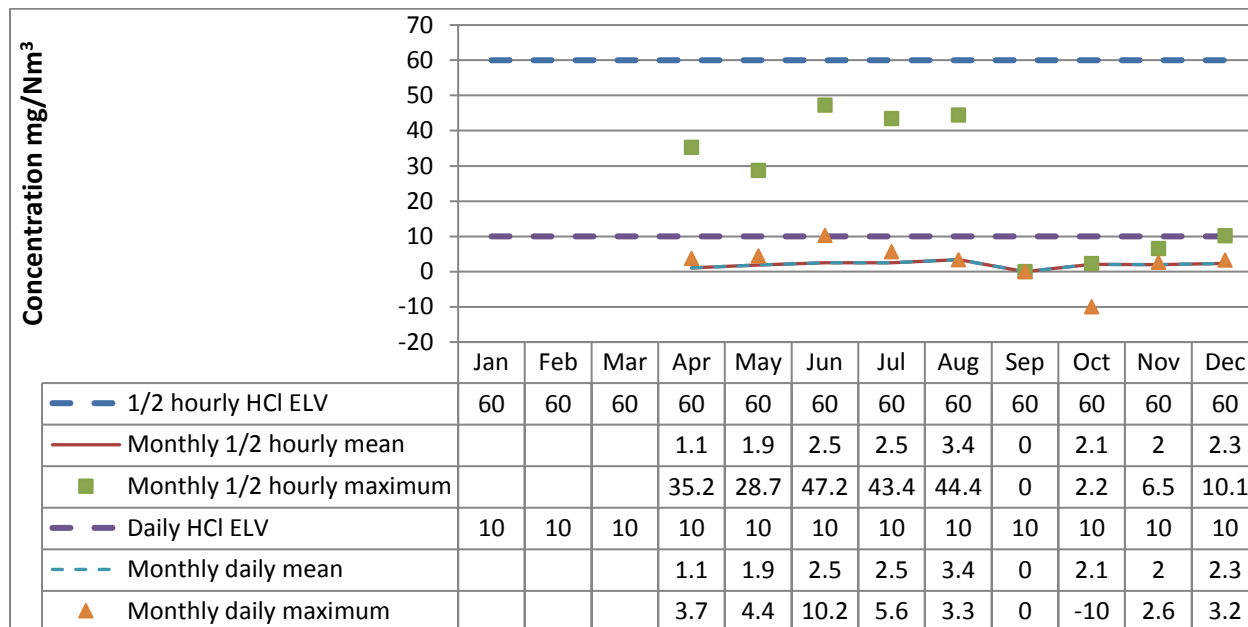
#### Line 1 - Hydrogen chloride

The following charts show the performance of the plant against its emission limit values (ELVs) for substances that are continuously monitored.
