Review of Coastal Processes and Associated Risks at Hengistbury Head

Poole & Christchurch Bays Shoreline Management Plan Review
Sub-cell 5f

Bournemouth Borough Council

September 28th 2009

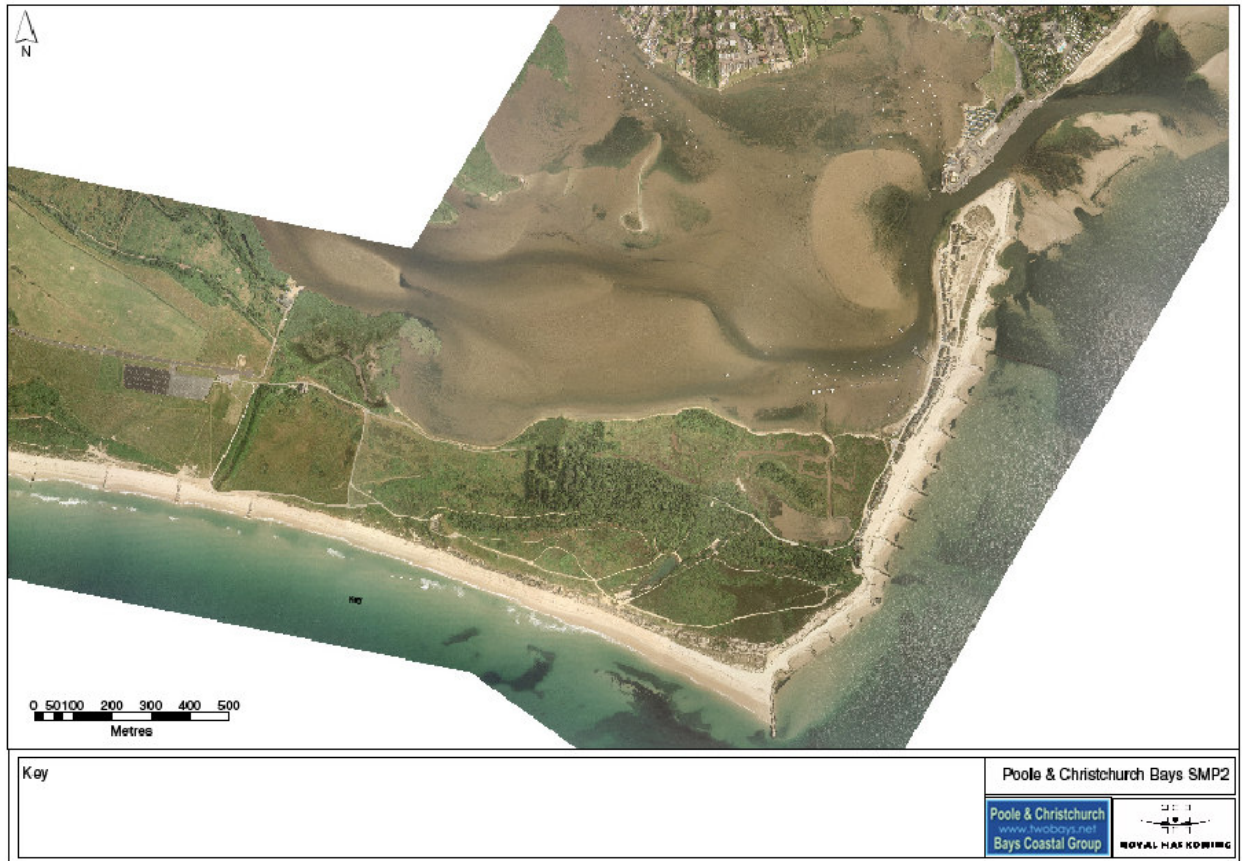
Figure 2.1 Aerial view of Hengistbury Head and Christchurch Harbour

Hengistbury Head is a key feature within the Poole and Christchurch Bays SMP frontage (see Figure 2.1 below) and plays an important role in dictating the morphology of the adjacent shoreline. It is a key geomorphological controlling feature, one that has been very influential in fixing in place (albeit artificially) the current plan forms of both Poole and Christchurch Bays. Christchurch Bay itself still appears to be adjusting to a form of natural equilibrium, demonstrated by a pattern of continuing retreat.

A shallow-sloped, dissipative mixed sand and shingle beach fronts Double Dykes and the south-west facing cliffs of Hengistbury Head. Maintaining the width of the beach reduces the erosion of the Hengistbury frontage due to the protection it affords the soft cliffs from waves. Some contemporary erosion is ongoing at Hengistbury Head and Double Dykes (see Section 3 for more detail) but it is largely held in check by the current management practices. A key feature here is the Long Groyne, built in 1938 at the southerly most point of Hengistbury Head (see Figure 2.3). It has assisted in retaining sediments and consequently beach widths to the west of the groyne. The Long Groyne and its influence on sediment levels and beach width can be seen clearly in Figures 2.1 and 2.3. It is discussed further in Section 4.1.

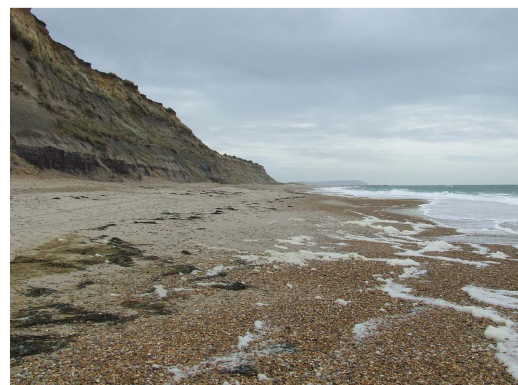
Figure 2.2 Hengistbury Head Cliffs and beach looking east

The cliffs at Hengistbury Head are of Tertiary origin and are primarily composed of Barton Clay, Hengistbury Beds, with overlying Boscombe Sands. These deposits are capped by Plateau Gravels. The cliffs rise to a height of 36m OD in the area known as Warren Hill. Figure 2.3 shows the topography of the study site.

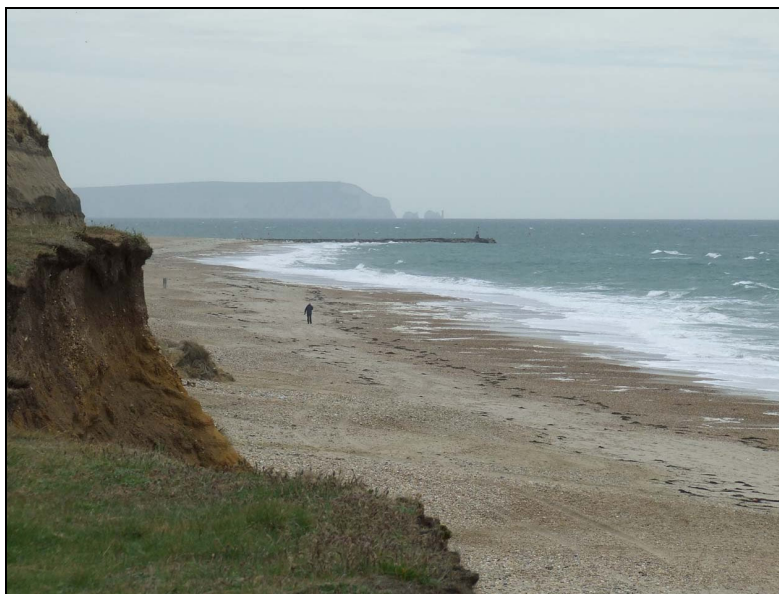
Figure 2.3 Hengistbury Head beach, looking toward the Long Groyne

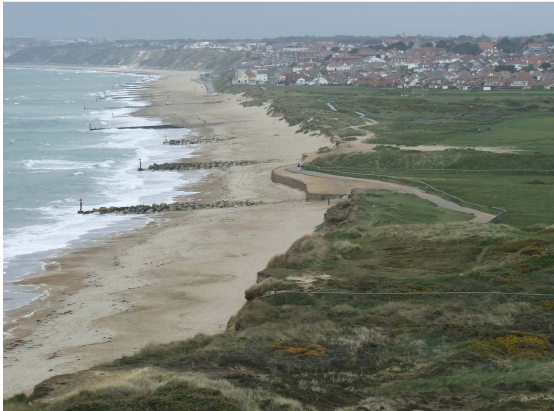
**Figure 2.4 Double Dykes frontage,
west of Hengistbury Head cliffs**

The Double Dykes area is particularly low lying compared to adjacent areas and at a width of only some 400m between the sea and the estuary it is perceived as posing the greatest threat of a breach into Christchurch Harbour. The topography across this section ranges between 5m and 8m OD (see Figure 2.4 above).

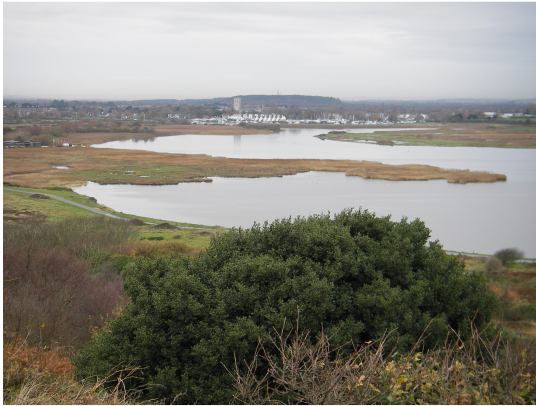
Figure 2.6 Christchurch Harbour, looking from Warren Hill

The nature of the ebb and/or flood dominance of the Harbour is complex. The mouth is generally ebb dominant, due to higher flows on the ebb tide, and the influence of high fluvial flows. However, both ebb and flood deltas are present on either side of the Harbour Mouth – Figure 2.6 below demonstrates this well. There is the potential for flood dominance through the mouth during surge and storm events, when there is an

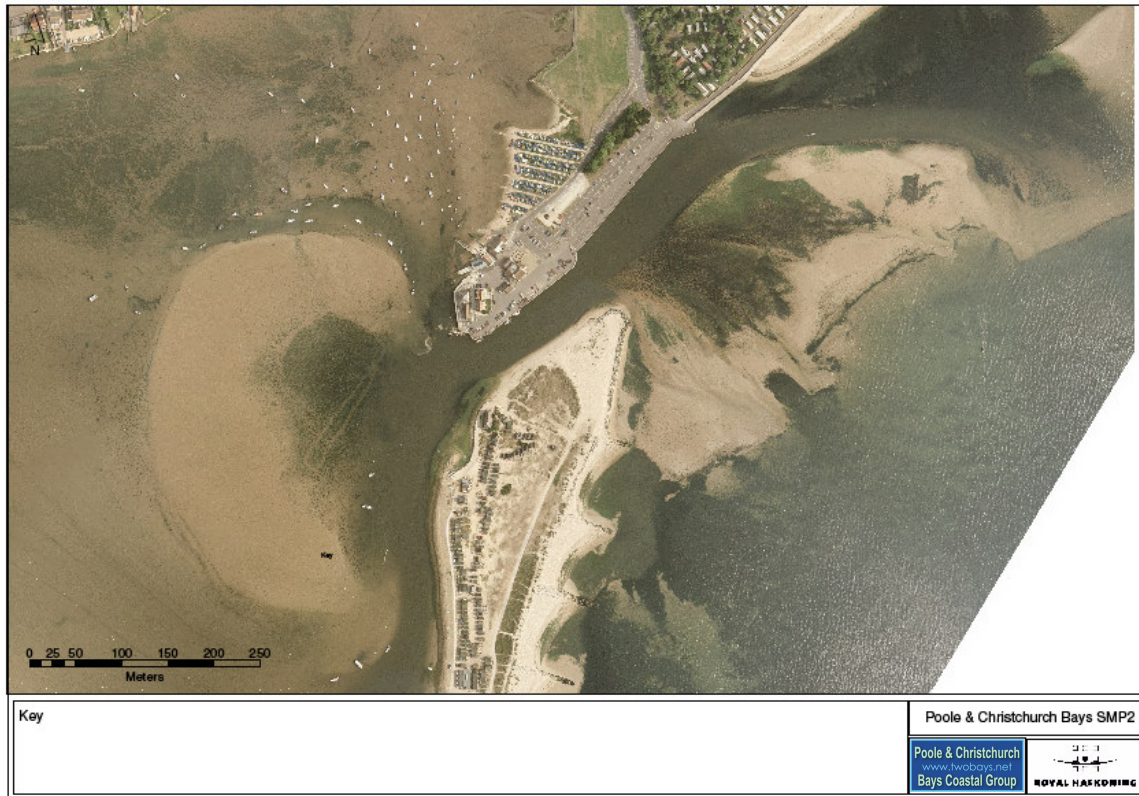
Figure 2.7 Christchurch Harbour Mouth, showing the Mudeford Run entrance channel, Mudeford Spit (bottom centre) and Mudeford Quay

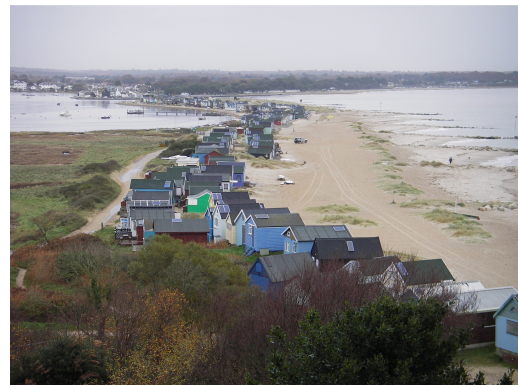
Figure 2.8 Mudford Spit, looking north

Mudford Spit is an important site in terms of recreation and tourism, with a large number of beach huts present (see Figure 2.8) with each hut having a financial value of tens of thousands of pounds. Such use of the Spit has helped to justify the cost of protection works along its seaward edge.

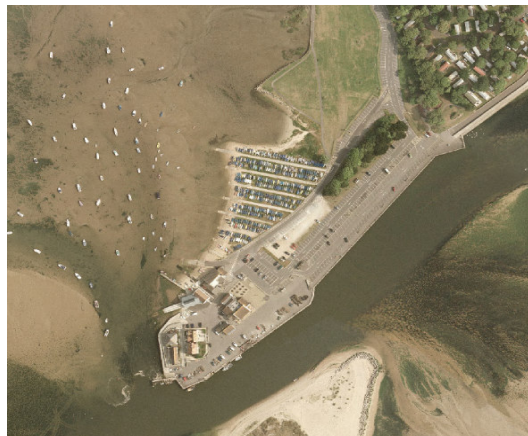
Figure 2.9 Mudford Quay Spit, showing position of the Mudford Run entrance to Christchurch Harbour
(Source: Channel Coastal Observatory)

As can be seen from Figure 2.9, although initially a natural spit feature, Mudford Quay is now heavily modified through manmade protection and no longer has any natural evolution occurring. It protects a significant number of pleasure craft moorings to its Christchurch Harbour leeside and is defended along its seaward side, firmly fixing the north-western boundary of the Mudford Run in its current position. An access road, car park and other assets are built on top.

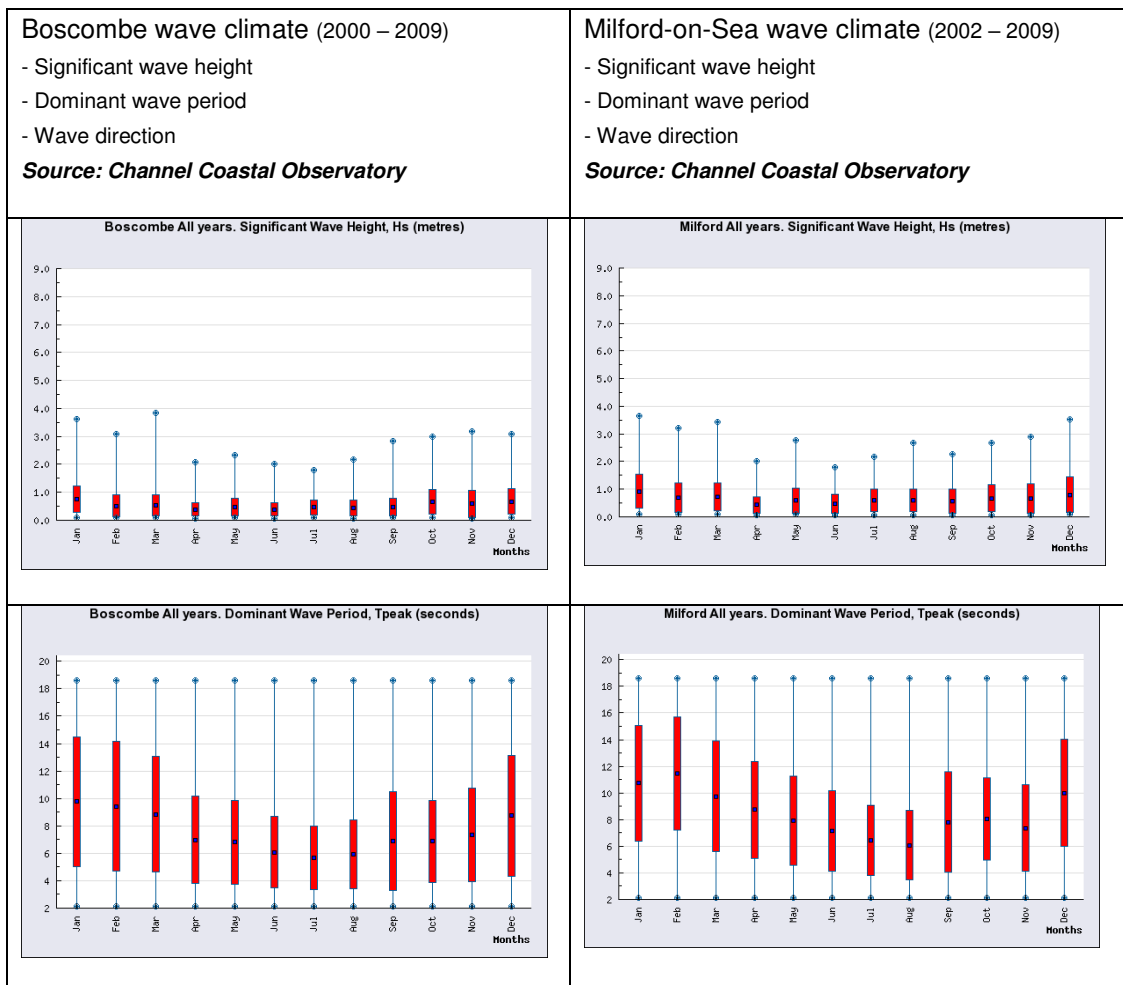
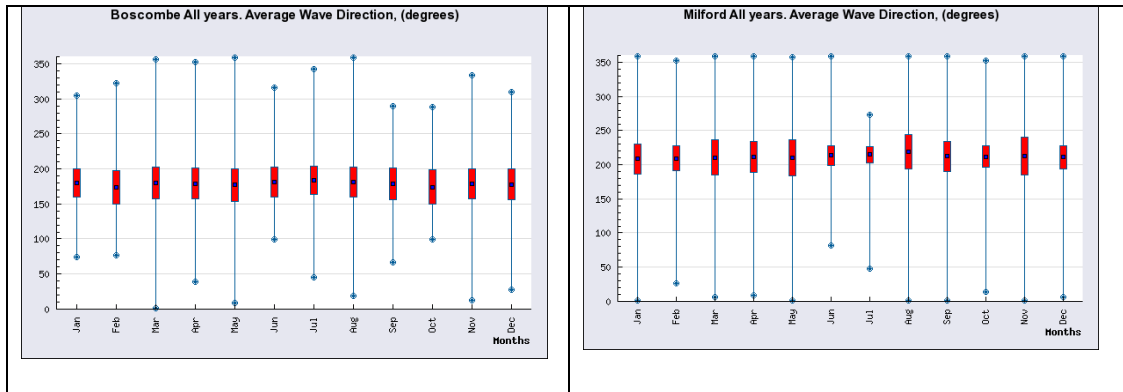
Figure 2.10 Comparative wave climates from Boscombe and Milford-on-Sea

Figure 2.10 also shows the wave directional values for each location. The dominant due-south direction ($\sim 180^\circ$) of incident wave approach at Boscombe, provides evidence that waves approaching from the south-west are still undergoing some refraction (and therefore attenuation) due to the sheltering effect of the Isle of Purbeck at that point. The Milford buoy records a dominant south-south-westerly wave approach ($\sim 212^\circ$), demonstrating that there is effectively very little shelter provided from the dominant south-westerly wave climate at this location.

However the difference in wave climate energy between Boscombe and Milford overall is not great. The buoys are not quite equidistant from Double Dykes (Boscombe is closer) but interpolating west to east between the two buoys locations, indicates that the general sheltering effect of the Isle of Purbeck is much reduced by the time one reaches the Double Dykes and Hengistbury Head frontages. At that point it would be expected that only a slight refraction is being induced and therefore attenuation of the wave energy is slight. It is suggested that the Beerpan Rocks provide some shelter to Hengistbury Head (Harlow, 2009), however due to their location approximately due south of the Long Groyne, they would not provide any shelter to the Double Dykes area from south-westerly waves.

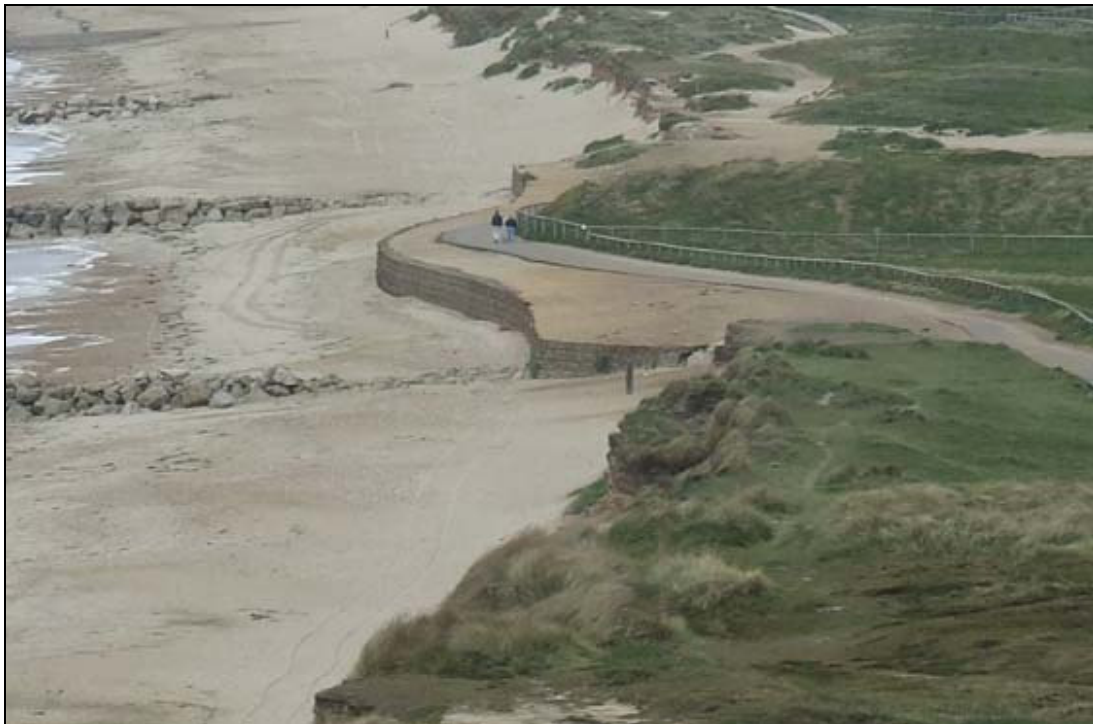
Figure 3.1 Gabion defences at Double Dykes (note cutback of low gravel cliffs immediately adjacent to defences)

Directly in front of Double Dykes, the low cliff line is strengthened and defended by gabion baskets (Figure 3.1).

The low cliff line displays clear signs of being eroded and cut back on those sections to the east and west of the area defended by gabions (see Figures 3.1) and this is particularly noticeable immediately adjacent to the gabions (see Figure 3.1). The recession of the low cliff line is irregular and is more severe adjacent to access points on to the beach (see Figure 3.2 and Figure 3.3).

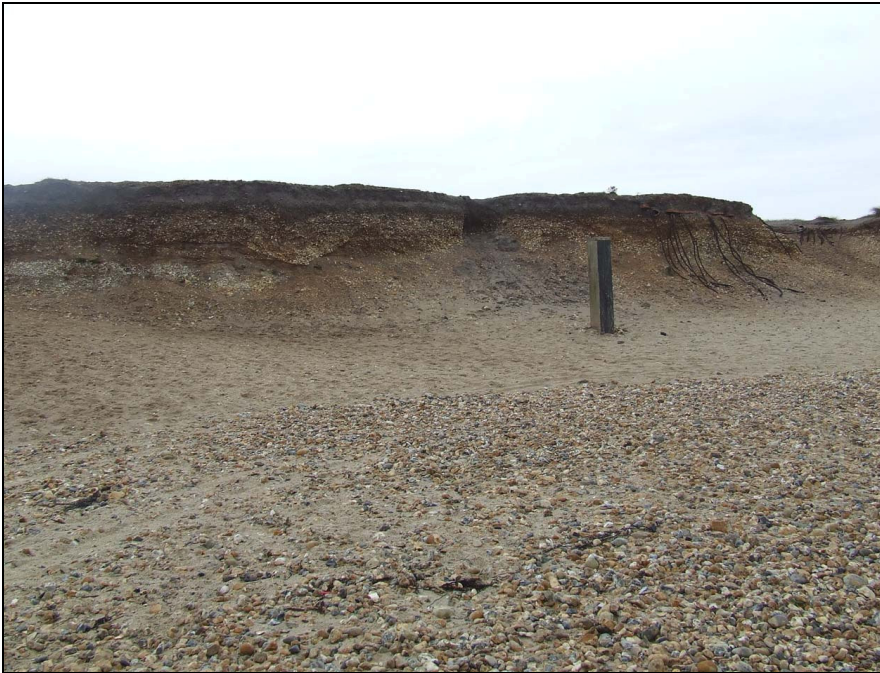
Figure 3.2 Low cliffs at Double Dykes displaying erosion

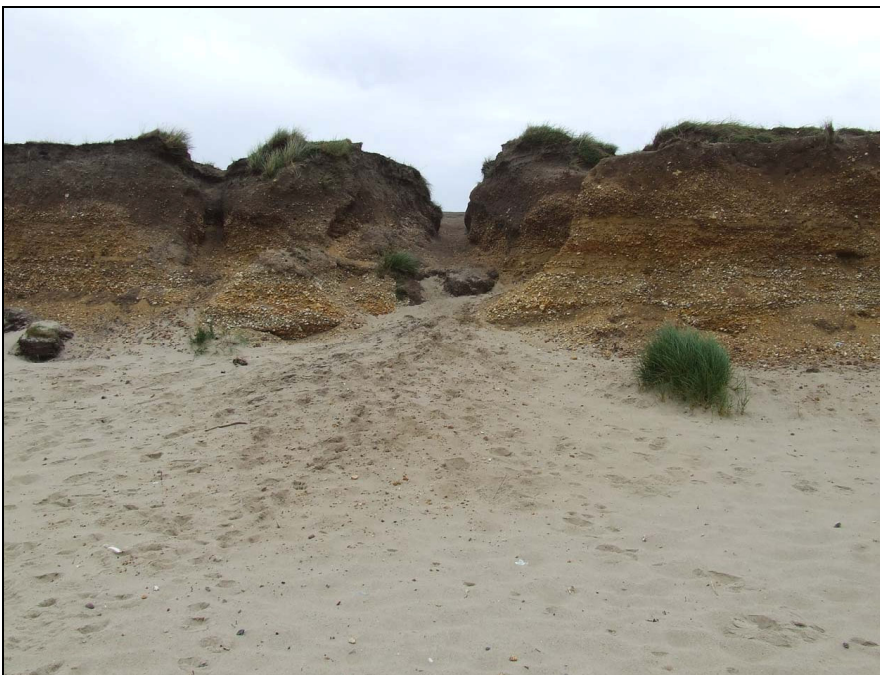
Figure 3.3 Access point showing enhanced erosion

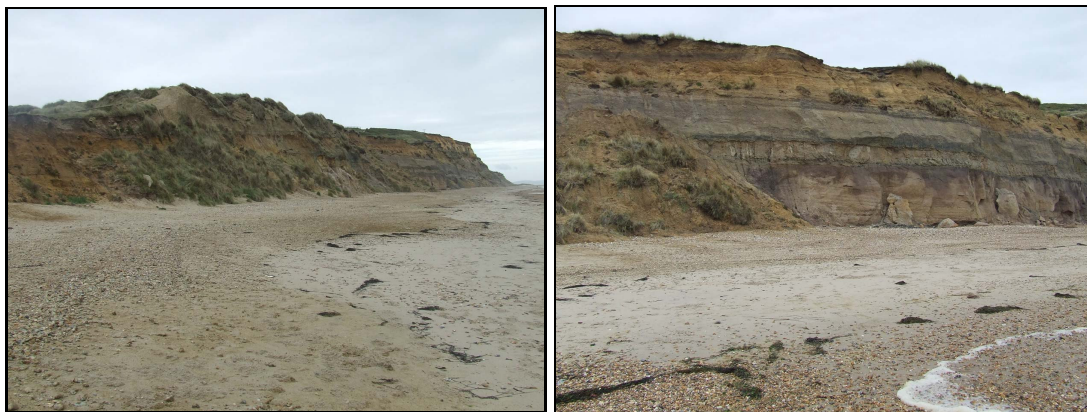
Figure 3.4 Hengistbury Head cliffs displaying exposed strata and evidence of erosion

In addition to the area immediately to the front of Double Dykes, the higher cliffs to the east also show evidence of erosion – see Figure 3.4. Although the evidence of active erosion is readily observed, there are also indications of at least some short-term stability within the frontage, examples being the vegetated, tussocky cliff toe (Figure 3.5) and sand accumulations on the upper beach against the low cliffs (Figure 3.6). The sand accumulations are known to have resulted following the recharge episodes along the Bournemouth frontage during 2006. Similar accumulations which followed the recharge in 1988 persisted for some 5 years before eroding away (Harlow, personal communication, 2009). This further reinforces the role the Poole Bay recharge plays in maintaining beach levels at Double Dykes and Hengistbury Head.

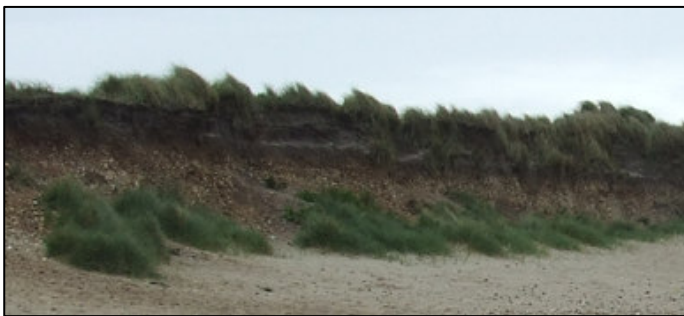
Figure 3.5 Vegetated cliff toe west of Double Dykes

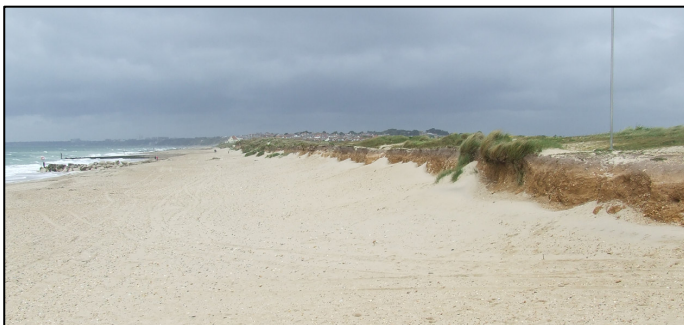
Figure 3.6 Upper beach sand accumulations, Double Dykes, looking west

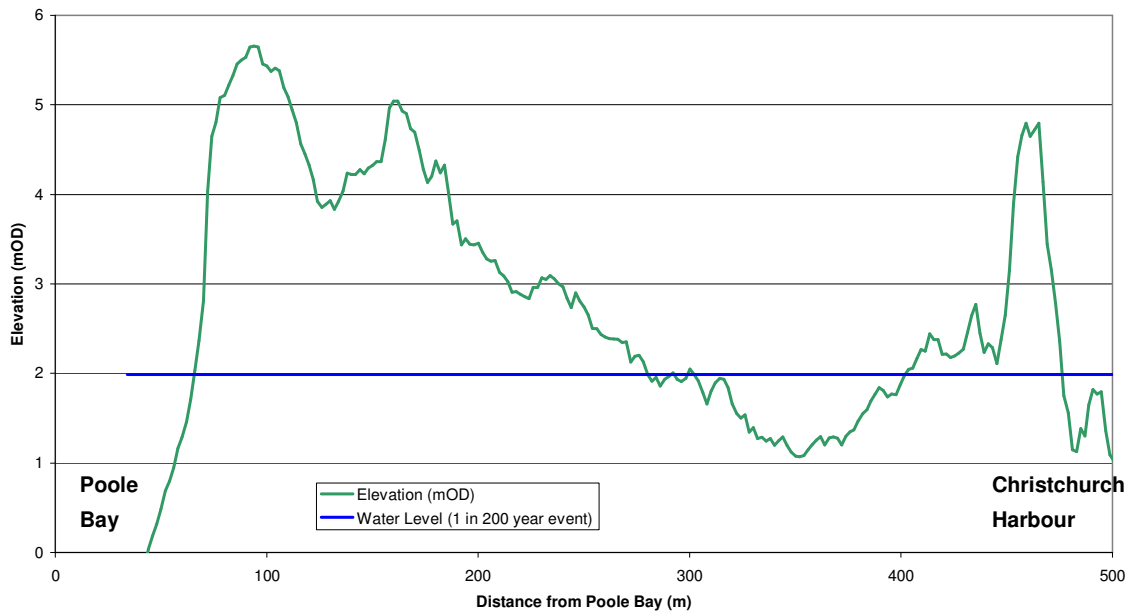
Cross Section Profile for "Double Dykes" Breach

Figure 5.3 Cross-sectional topography through Double Dykes showing height of 1 in 200 year extreme tide level (1.99mOD)

Cross section profiles of the Double Dykes area at risk of breaching can be seen in Figures 5.3, 5.4 and 5.5 in Section 5.

Figures 5.3, 5.4 and 5.5, show the cross sectional topography of three possible breach routes. This type of graphical representation of the risk has been given previously, by Halcrow (2006) and Harlow (1999). There is general agreement that although it represents the longest route, Figure 5.5 shows the most likely topographic route that a breach would follow. It should be noted that the graphs are not to scale and show a much exaggerated elevation compared to the barrier width. It is therefore useful to refer to Figure 5.7 in order to appreciate the dimensions of the barrier.

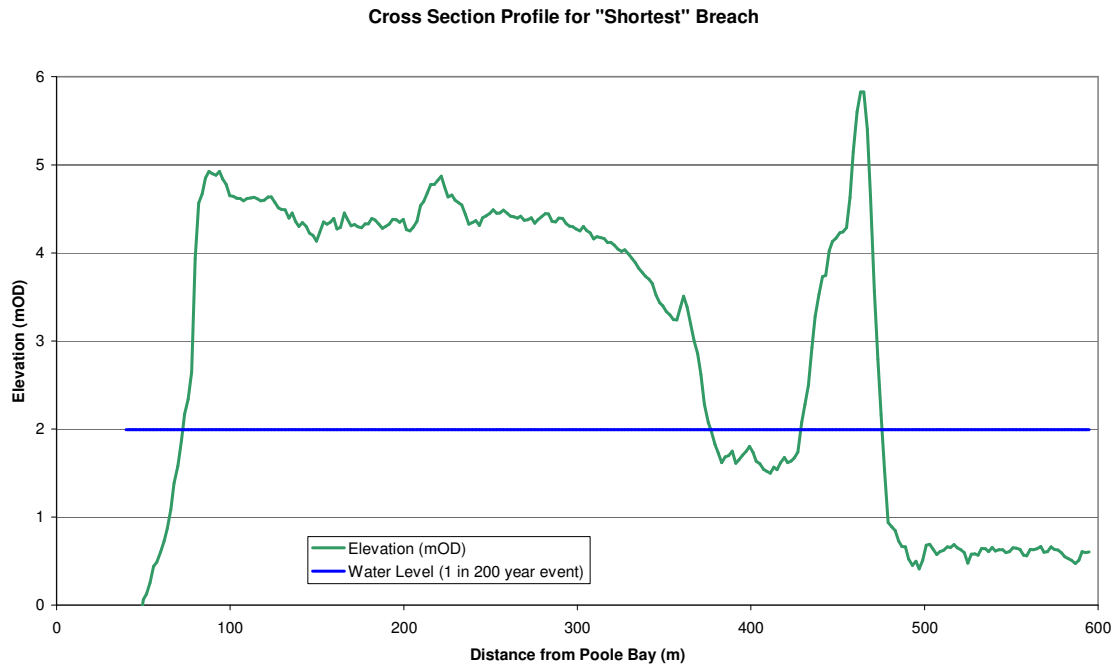
Figure 5.4 Cross-sectional topography through shortest distance breach route showing height of 1 in 200 year extreme tide level (1.99mOD)

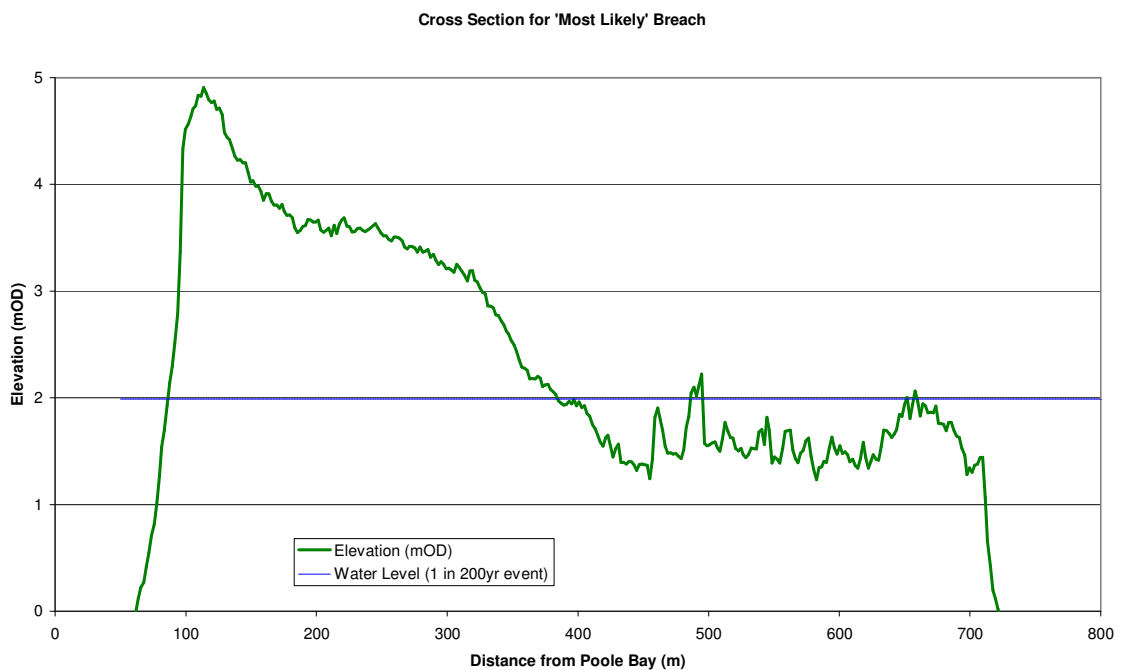
Figure 5.5 Cross-sectional topography across 'most likely' breach route showing height of 1 in 200 year extreme tide level (1.99mOD)
