Widnes Biomass Facility

Annual Performance Report 2018

Annual performance report for
Widnes Biomass Facility

Permit number: EPR/JP3132RV

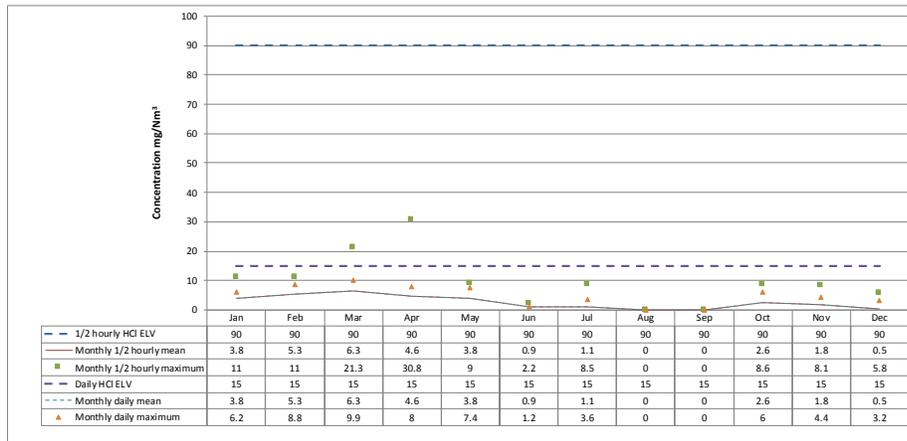
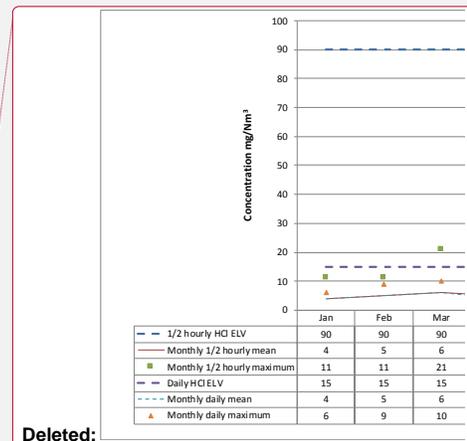
Line 1 - Hydrogen chloride

The following charts show the performance of the plant against its emission limit values (ELVs) for substances that are continuously monitored.

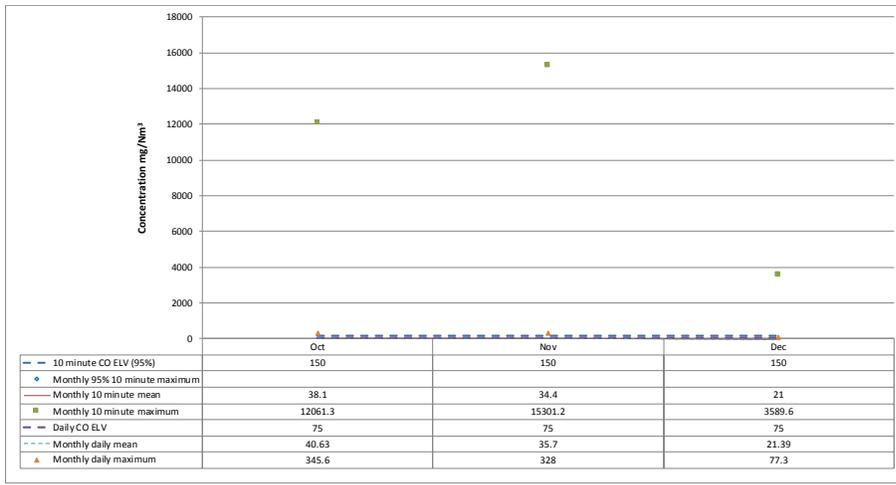
The Permit was varied in September 2018 to allow reporting of 10 minute averages for Carbon Monoxide. Therefore, data from October 2018 onwards is of this data.
