Location reference:	Minster Slopes to Warden Bay
Policy Unit reference:	4a04

SUMMARY OF THE PLAN AND JUSTIFICATION

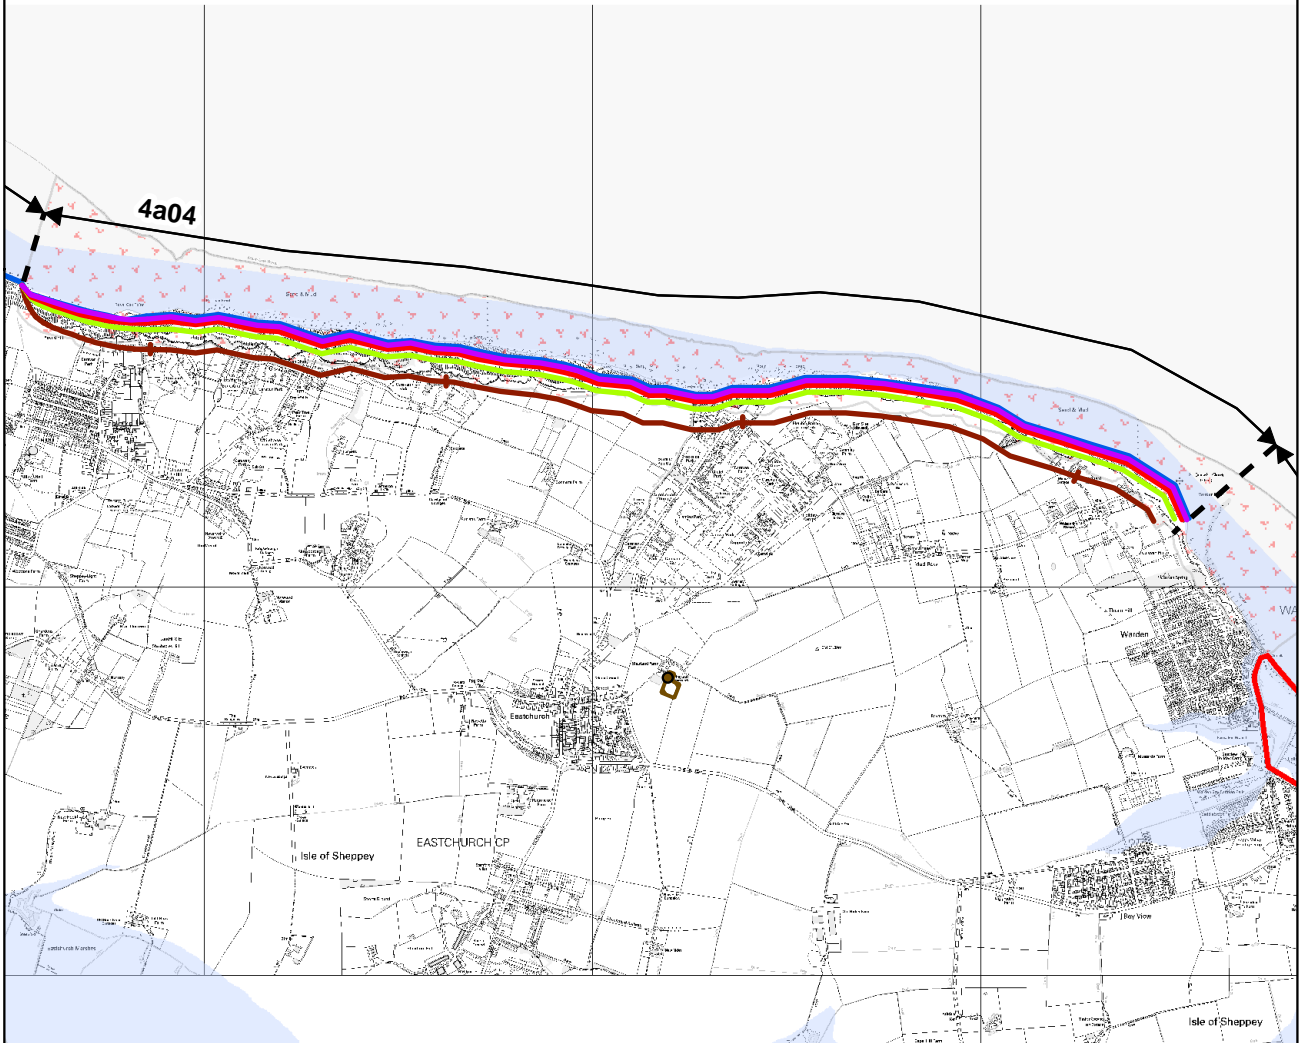
Erosion Lines

0-20 year erosion
-

20-50 year erosion
-

50-100 year erosion
-

50-100 year top of landslide
-

Current shoreline
-

Potential maximum long-term realignment option
-

2005 Indicative floodplain © Environment Agency

The eroding cliffs along the Minster Slopes to Warden Bay are of national conservation, geological and landscape importance. The long term recommendation is to allow continued erosion of the cliffs, which will maintain the geological exposures, environmental and landscape qualities of the frontage.

Development along this frontage is minimal, comprising a few residential properties, caravan parks, campsites and minor roads. Some of these assets will be at risk from erosion and landslide events within the next 100 years i.e. residential properties, caravan and camping sites. There is also a potential for loss of buried unknown heritage with erosion.
